Negligence of geological Investigations site leading to slope failure incidents: a case study from Saih Al Ahmar in Bidbid, Northern Oman

Talal Al-Hosni* and Sobhi Nasir

Department of Earth Sciences, College of Science, Sultan Qaboos University, P.O. Box 36, Al-Khod, PC 123, Muscat, Sultanate of Oman, *Email: hosni@squ.edu.om.

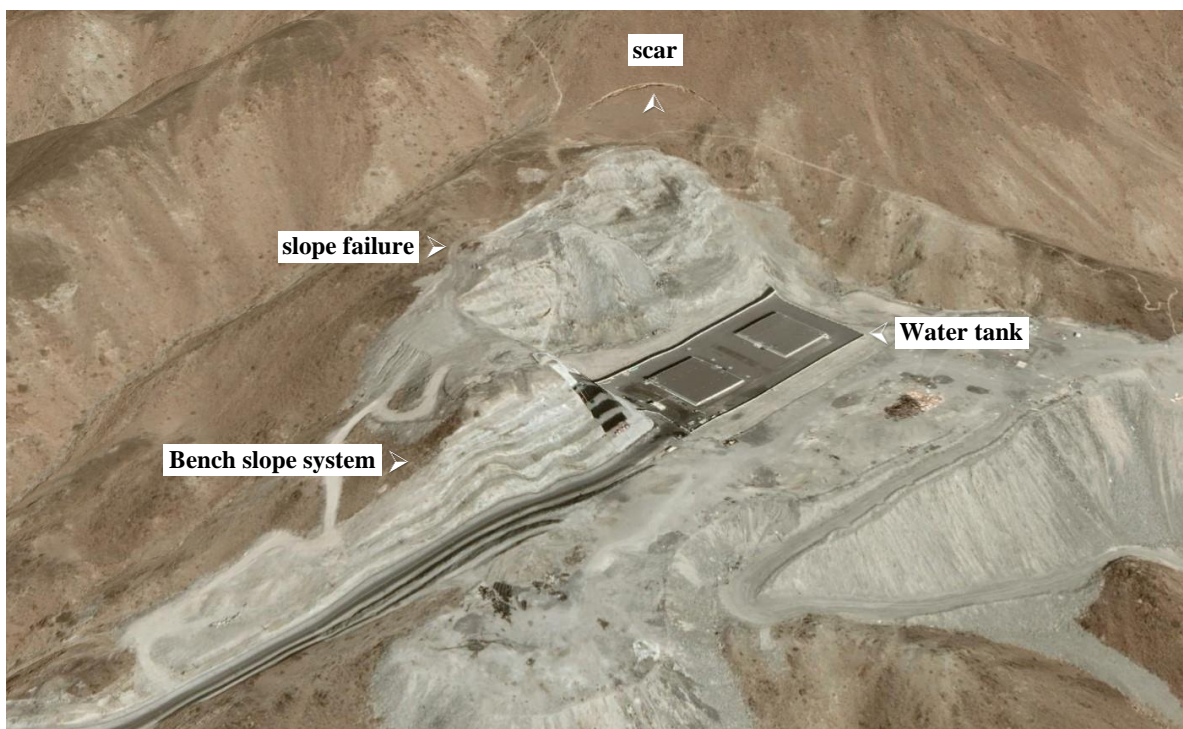
The landslide area lies around GPS UTM 40Q: 614650 m E, 2596623 m N (Figure 2). The Saih Al Ahmar water tank area in Bidbid traverses a geologically complex part of the Samail Ophiolite, where the topography of the ophiolitic rock sequence is characterized by steep slopes of 50-60°. The area is dissected by seasonal watercourses of wadis following the major fractures and forming the drainage pattern in the area.

Figure 2. Landsat Google image (20 Mar 2021) showing the water tank and slope failure above it.

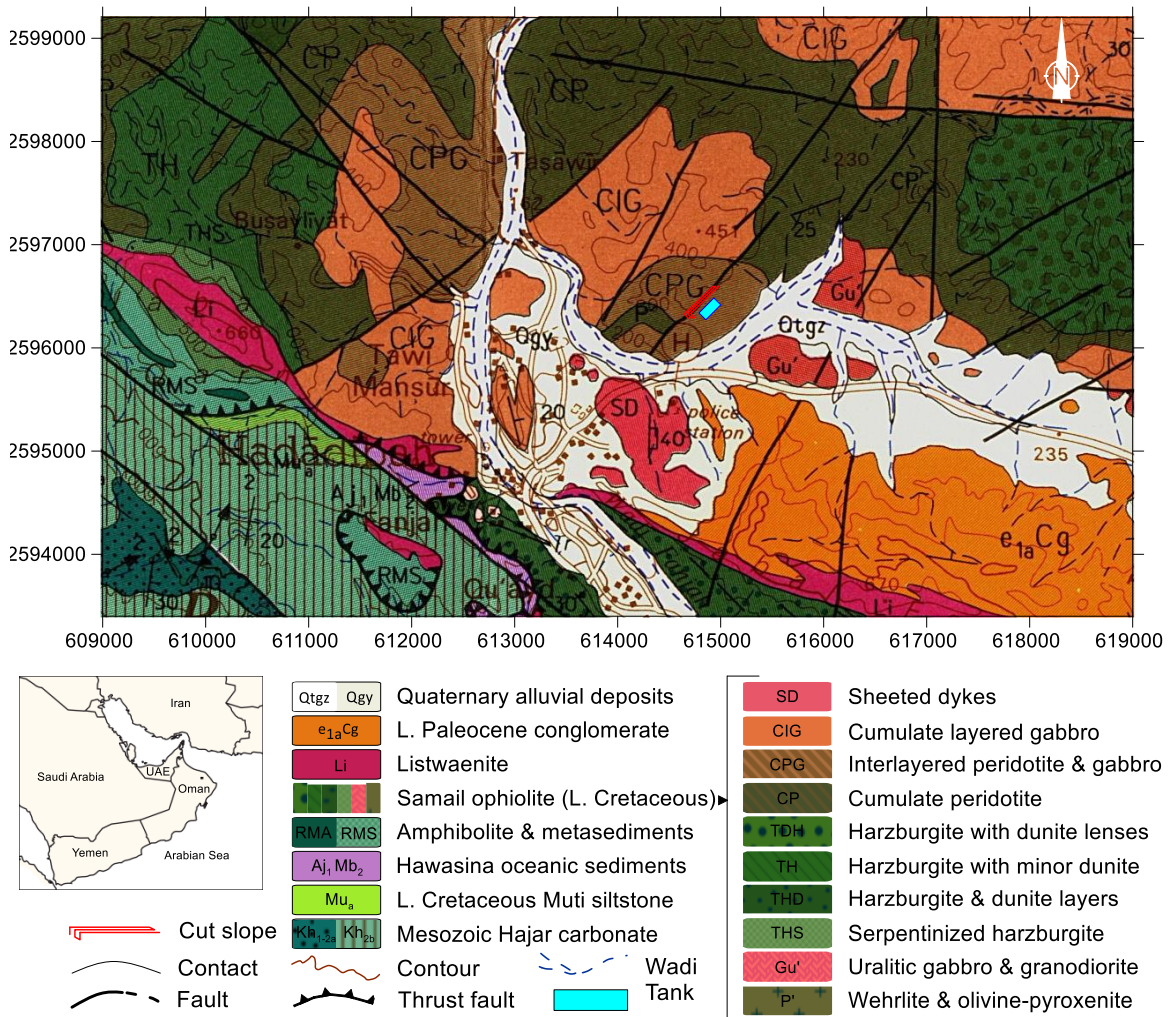
Figure 3. Geological map after Villey *et al.* (1986) to show the location of the slope failure and the geology of Saih Al Ahmar (Bidbid, Northern Oman) [19].

The landslide area is characterized by northwest-trending mountain ranges and NW and NE wadis (valleys) bounded by many NE, EW and NW faults (Figure 3). Viewing the failed slope from above (Figure 6), there is evidence of significant displacement at the back scarp with both loss of level and forward displacement on the scale of meters on the low side of the scarp. Tension cracks or dilated rock joints showing similar trends to the line of the back-scarp are located at levels higher than the back-scarp. A fault zone passing into the failed slope can be observed on the collapsed area and is apparently expressed as a series of tension cracks running across the failed area. There are blocks of rock mass that have rotated outwards from the slope within the vicinity of the tension cracks. A central portion of the failed area where the bench and berms have failed has been replaced with a slope of rock scree and disintegrated rock mass. At its maximum extent, the rock scree nearly extends to the face of the rock cutting. The amount of displacement on the back-scarp varies, ranging from around 0.2 to 3 m. The overall impression from the surveys is that a large-scale deep-seated failure surface or zone had formed within the hillside. The major orientations of induced fractures are N-NW and N-NE and they extend clearly across the area and within the slope above the water tank.

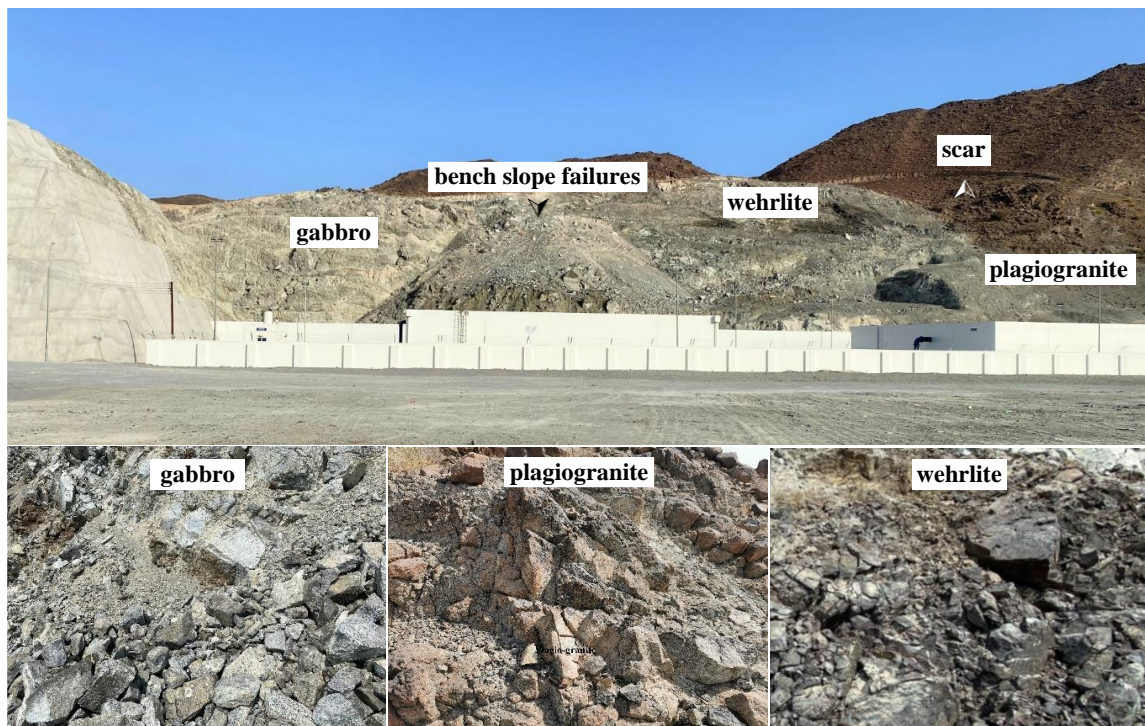
Based on the geologic mapping on the excavated slopes, the corresponding rock masses are classified into two main groups (Figure 4): - Group 1) Slightly weathered and highly fractured, highly jointed, moderately strong to strong gabbro and plagiogranite, and Group 2) Highly weathered and fractured, very weak to weak peridotite rocks (harzburgite, dunite and wehlrite). The rock strength (UCS) is 100 to 140 MPa for group 1 and 35 to 80 MPa for group 2 (Figure 5 and Table 1). The Schmidt Rebound Hardness test found values varying between 47 to 60 for rocks of group 1, and 14 to 35 for rocks of group 2. The low values of the UCS and Schmidt rebound hardness of group 2 rocks indicate poor surface conditions (Figure 5). The compressive strength values of rocks from group 1 (Gabbro) is relatively high, but these rocks are highly fractured and highly jointed in the field.

Figure 4. The excavated slopes are made of weak peridotite rocks (harzburgite, dunite and wehlrite) and strong gabbro and plagiogranite.

The area traverses a sequence of highly deformed gabbro underlain by highly weathered and serpentinized peridotites (dunite, wehrlite and Harzburgite) of the Samail ophiolite (Figure 4). The movement was facilitated by the varying shear strengths of different rock masses in contact with each other, mainly along the contacts between the harzburgite, wehrlite, plagiogranite and the gabbro. The Gabbro rests on the soft peridotite that becomes highly plastic when serpentinized. This plasticity increases the possibility of slippage, which is multiplied by the gravitation forces along the steeply dipping planes and contact zones between different lithologies, which do not bond well. Serpentinized peridotite rocks are present along the fracture surface of the rock formation and may have acted as a lubricant and greatly enhanced the slope slide. The weak harzburgite and wehrlite within the slope would have

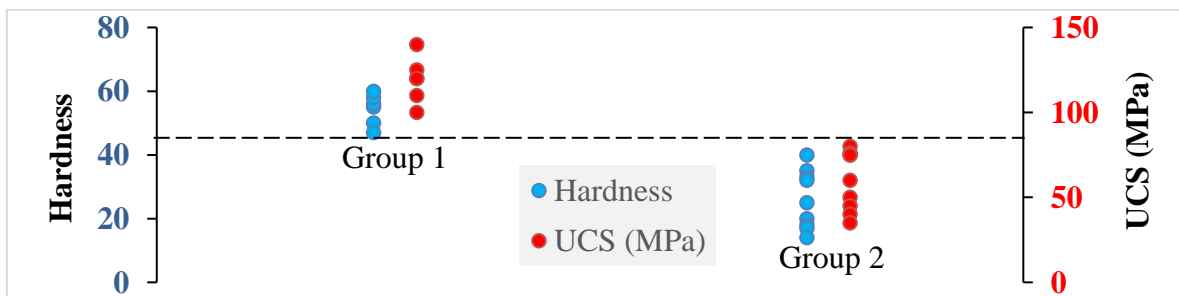
Figure 5. High values of the uniaxial compressive strength (UCS) and Schmidt rebound hardness for rocks of group 1 (gabbro) compared to that of group 2 (peridotite).

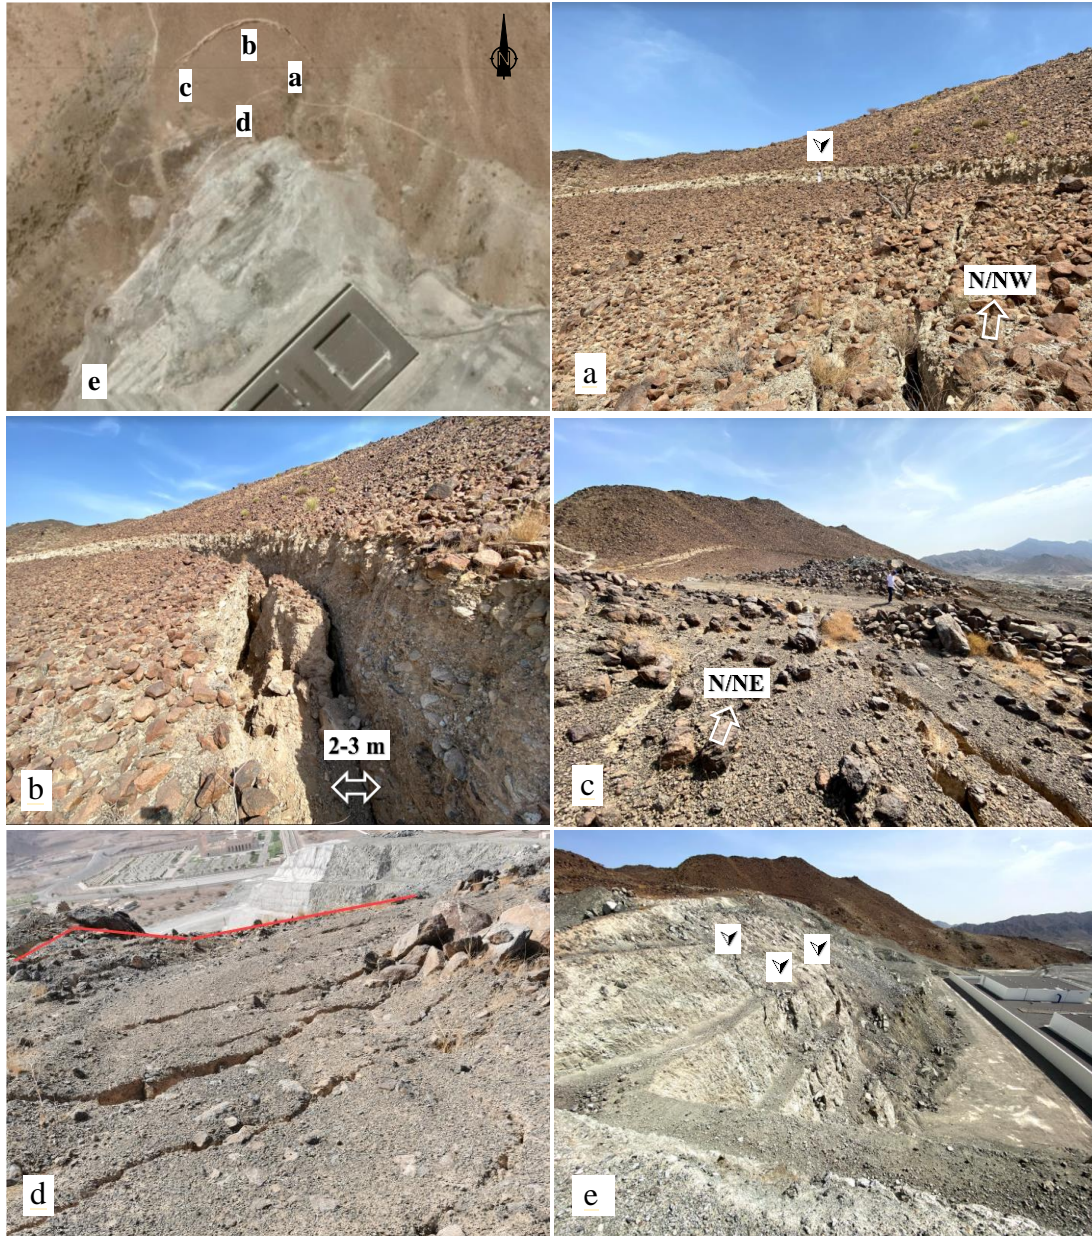
The collapsed cut slope occurs at an elevation of 71 m above tank level, and the equivalent slope angle is 50 to 70° for the excavated slopes. The height of the mountain is 388 m above sea level. The major orientation of the failure surface is undulated with strike orientation ranges between 330° and 355° and between 020° and 040° dipping very steeply towards the south and southwest. This landslide is rotational as the surface of rupture is curved concavely upward (Figure 6).

Figure 6. The surface of rupture is curved concavely upward (a), the vertical displacement is 1.8m in the center decreasing towards the sides (b), while the horizontal displacement is up to 3m (b) and the major orientations of induced fractures are 330° to 355° (N/NW) and 020° to 040° (N/NE) (a and c). The fractures extend clearly with the slope above the tank area (d and e).

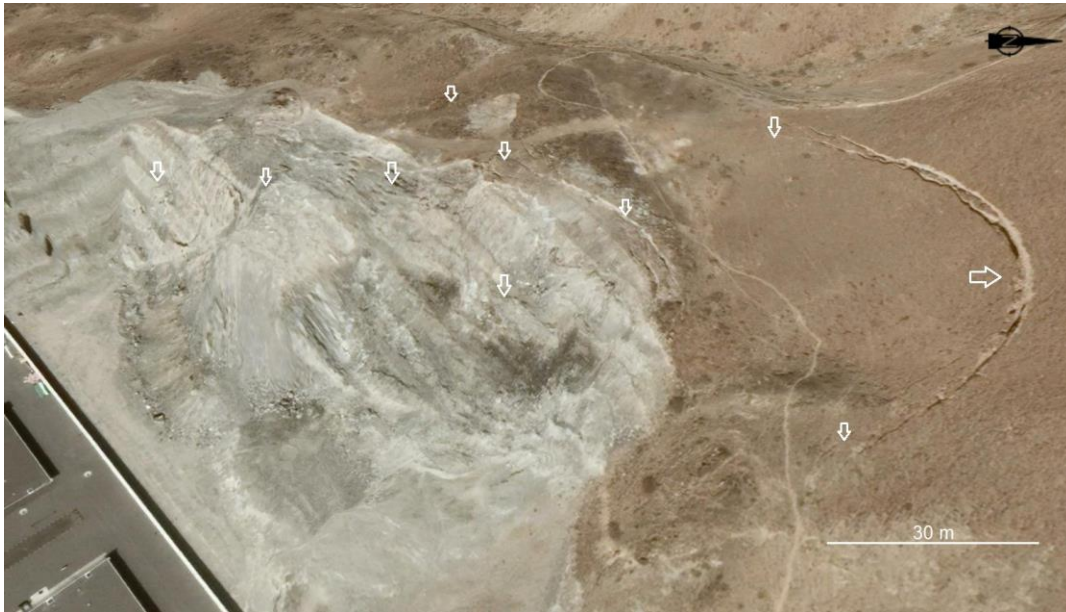
Google satellite images show that slope failure started between 28 and 31 October 2019 as a result of major slope excavation and removal of the toe support for constructing the water tank area (Figure 8). Upon approaching the failed section, the cut benches and berm lines show a convergence, resulting from the forward displacement of the failed slope. For this region, the sense of slip movement is estimated as south to southeast. In comparing the imagery pre- and post-failure, it is found that certain key characteristic features on the berms as detected on the 2019-2021 imagery had displaced downslope by distances of 0.2 to 3 m. The images of 2021 (Figures 7 and 8) show more clearly the surface of the tension cracks and many features that trend in the same fashion as fractures and joint set, indicating that there are likely to be many planes of weakness parallel to the fault zone running through the failed slope. There are also other surface cracks that are trending nearly perpendicular to the slope.

Figure 7. Collapse of benches initiating large fractures parallel to the main slide area.

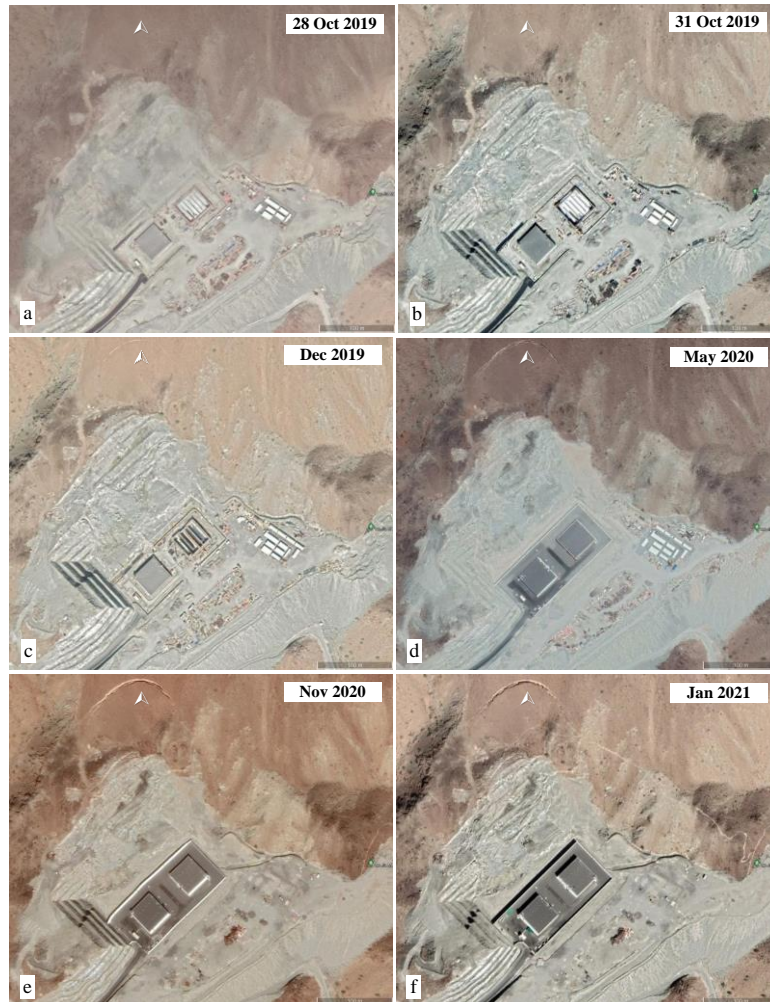
Available Google satellite images are dated October 2016 to September 2021. These satellite images show that construction started sometime between September and October 2016, as no construction can be observed in August 2016. In the imagery before October 2019, the cut slope had been advanced down to around the base level of the water tank area, through the full vertical depth of excavation (Figure 7). Deep and long cracks can be observed in the area above the cutting after October 2019. It should be noted that the ground falls significantly in elevation after that date.

Figure 8. Satellite images (a-f) show that slope failure started between 28 and 31 October 2019 (a and b) as a result of major slope excavation and removal of the toe support in order to construct the tank.
