An Investigation of Excessive Seepage from the Al-Fulaij Recharge Dam, Oman

Abstract: The Al-Fulaij recharge dam is located on the Al Batinah coast in Oman and was constructed in 1992. The dam is about 3.3 km long and 7.7 m high with a storage capacity of 3.7 million cubic meters of water. It is an earthfill dam with silty, sandy gravel fill in the embankment. Excessive seepage of between 5,000–12,500 m³/day was observed during floods in 1993, and several sinkholes were noticed close to the upstream toe. Remedial work consisting of an upstream blanket and a cut-off trench wall was performed in 2000. However, these remedial measures failed and almost the same seepage was noticed again during the impoundment. This paper investigates possible causes of the seepage using a finite element model. The input data for the model were collected from site investigations and field records during the construction and monitoring of the dam. The study reveals that the most probable cause of the excessive seepage is the presence of a permeable soil layer underneath the dam due to the dissolution of the gypsum material.

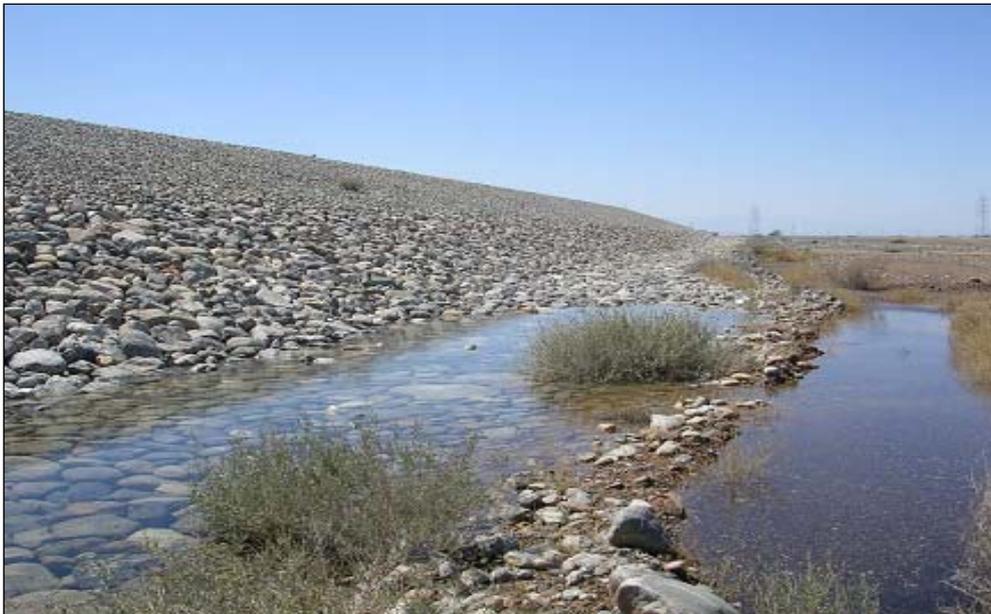
During floods, significant seepage has been observed at many points downstream of the dam (Fig. 3). As a result of the gypsum occurrence, numerous sinkholes, probably a few hundred within the reservoir basin just upstream of the dam, were formed. They are

Figure 3. Seepage from the dam.

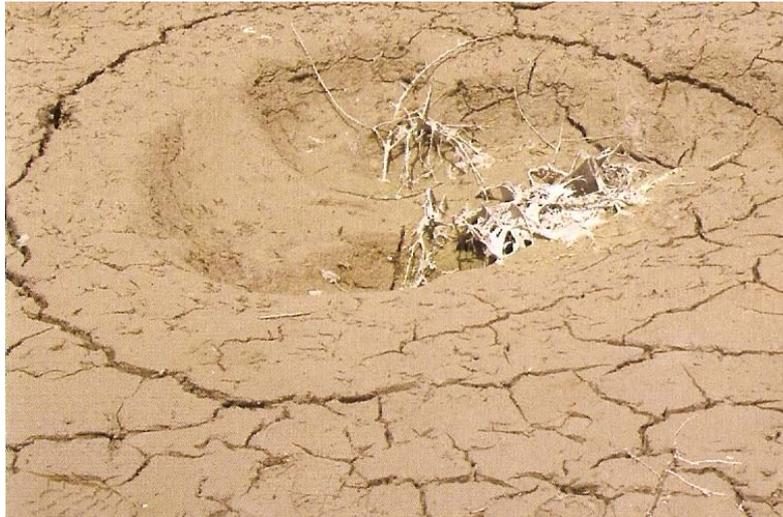
mostly circular but sometimes elongated, sinuous and channel-like (Fig. 4). Typically the sinkholes are 0.4–0.6 m in diameter with a depression of about 0.2 m deep, with the occasional sinkhole measuring 0.3–0.4 m deep (Binnie Partners Overseas Ltd. 2001).

Figure 4. A sinkhole in reservoir area about 40 m from the dam heel.

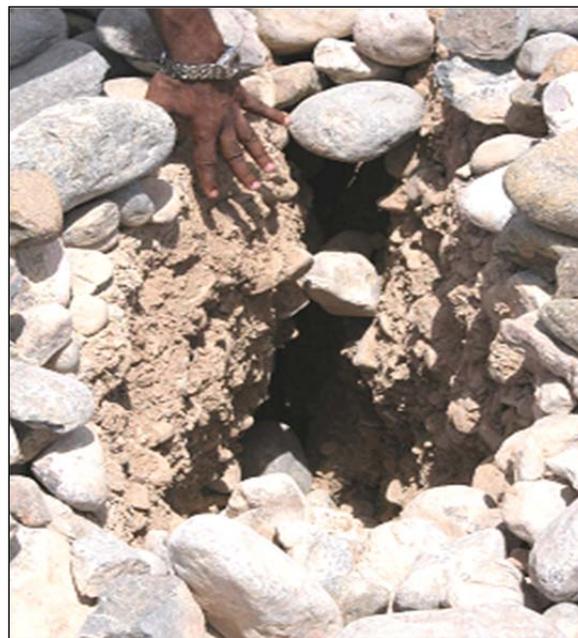
Figure 5. Crack in the crest of the dam at chainage 2+700.

A crack in the crest of dam embankment about 5–7 m long and 80–100 cm deep running parallel to the dam axis was also noticed at about chainage 2 + 700 (Fig. 5). The formation of this crack may have been due to some settlement in the foundation caused by gypsum leaching from the foundation.

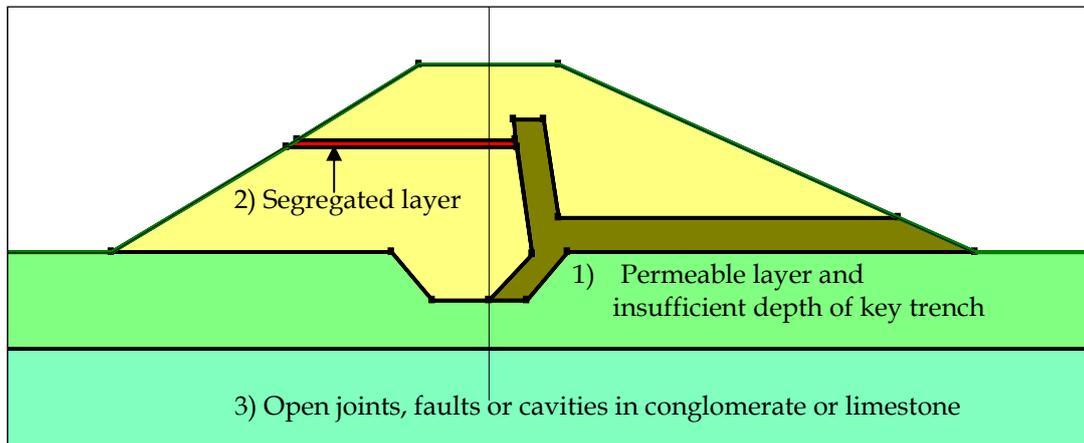
- The presence of a permeable soil layer beneath the dam as a result of gypsum material dissolution and the insufficient depth of the key trench.
- Seepage through the limestone or the hard strata as a result of cavities, faults, or open joints.
- Seepage through the dam body because of the segregated layers of fill.

Figure 6. Possible causes of seepage.

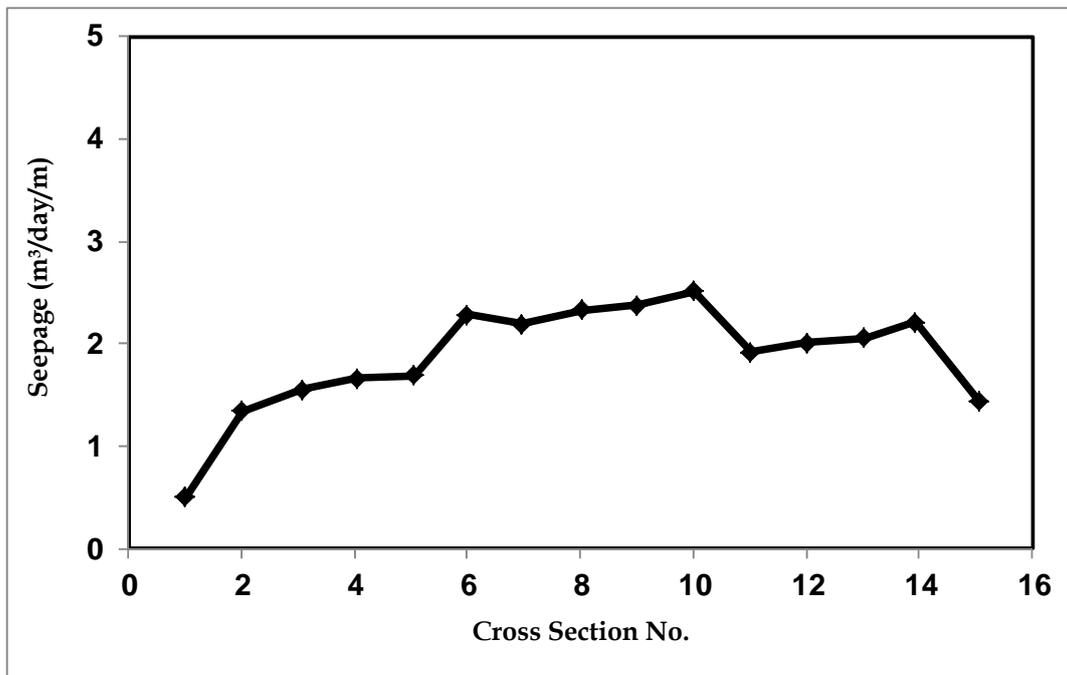
Figure 8. The seepage modeling results of the design case of Al-Fulaij dam.

The seepage modeling results of this case (Fig. 8) show that the seepage quantities of the design case range from 0.50–2.450 m³/day/m (total seepage 1250 to 6125 m³/day). During the impoundment, 5,000–12,500 m³/day of seepage was noticed per day. Based on this, trials were carried between 5,000 and 12,500 m³/day out using the modeling program to find out the corresponding k -value of the foundation

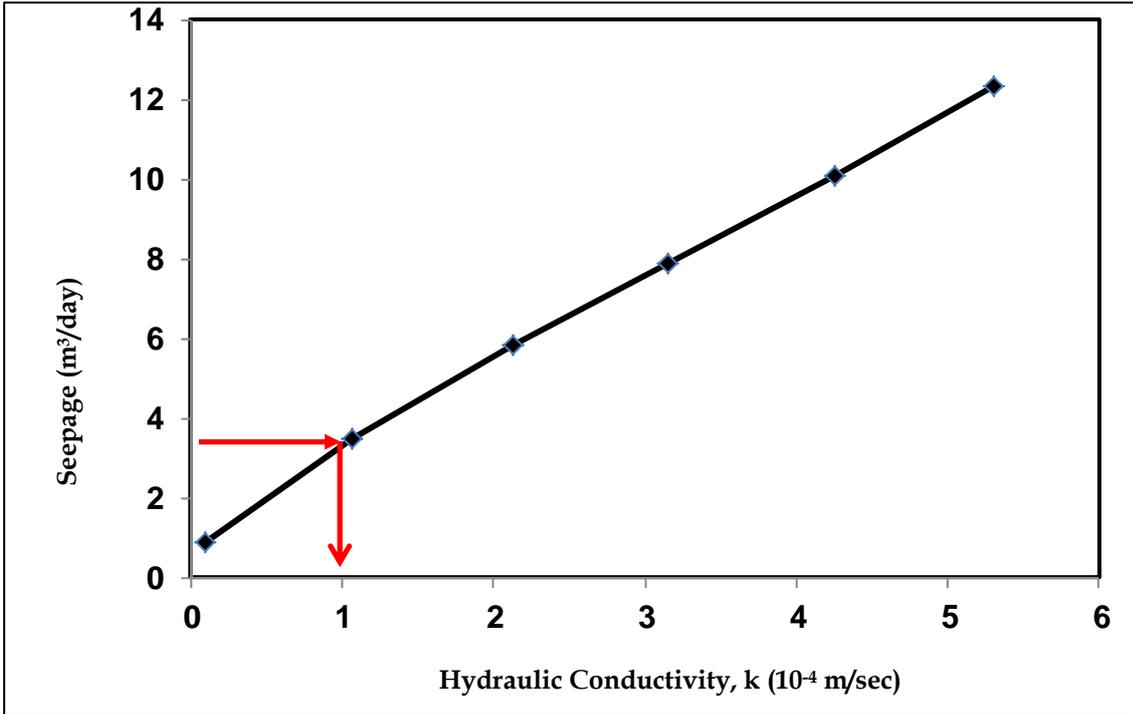
After conducting the trials, the average k -value was estimated at 1.00×10^{-4} m/s (Fig. 9). It is clear that the average foundation permeability was higher than the one obtained during the feasibility study. This is because the leaching process of gypsum material as a result of water flowing underneath the dam created voids within the dam's soil structure.

Figure 9. Trails to obtain the revised k-value of the foundation material.

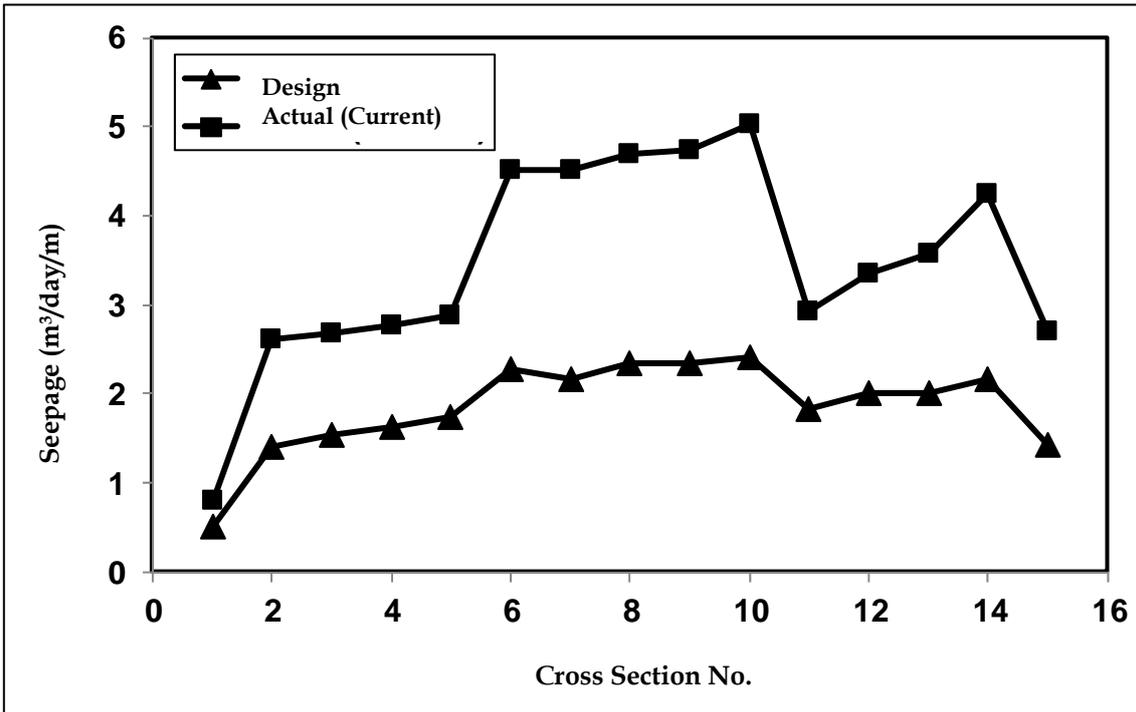
In this section, the actual case was simulated using the revised permeability value of the foundation material. The results that were obtained from the modeling of this case along with the design case are presented in Fig. 10. As can be seen, the seepage quantities of the actual case ranged from 0.85–5 m³/day/meter with a total amount of seepage between 2,125–12,500 m³/day, which is about double the seepage for the design case.

Figure 10. The seepage modeling results of the design and actual cases.

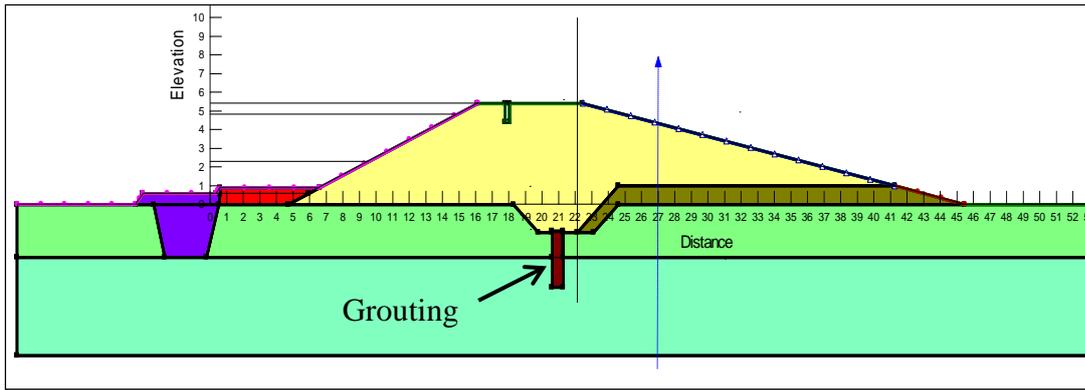
Figure 11. Grouting at the dam foundation as modeled in the program.

cutoff wall as shown in Fig. 11. The results of the dam modeling with the grouting curtain along with the current case are shown in Fig. 13, which demonstrates that the seepage quantities after applying the grouting range from 0.5–2.6 $\text{m}^3/\text{day}/\text{meter}$ (500–2,600 liters/day/m) whereas the seepage quantities of the current case range from 0.85–5 $\text{m}^3/\text{day}/\text{meter}$ (850–5,000 liters/day/meter). This shows 41–48% expected decrease in the seepage quantities. It is very important to mention here that grouting also has the advantage of improving the stability of the dam which is achieved by making the foundation denser since it will replace the materials which were washed away and prevent any depression or settlement of the dam foundation.

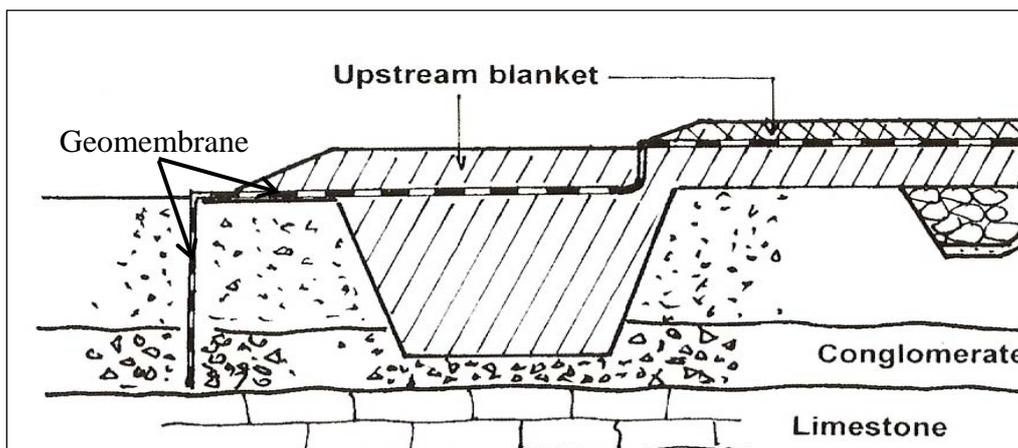
Figure 12. Dam with geomembrane.

A geomembrane can also be used to control seepage by inserting sheets of this material on the upstream face of the dam and extending it down to be anchored in the limestone (Fig. 12).

The figure shows the seepage profile of the dam when using the geomembrane. The value of hydraulic conductivity (k) used in the program for the geomembrane was 10^{-9} m/second. As can be seen from Fig. 13, the seepage quantities after installing the geomembrane range from 0.4–1.8 $\text{m}^3/\text{day}/\text{m}$ (400–1,800 liters/day/meter) whereas the seepage quantities of the current case range from 0.85–5 $\text{m}^3/\text{day}/\text{m}$ (850–5,000 liters/day/meter). This shows an expected decrease in the seepage quantities between 53–64%. This means that technically using the geomembrane is the best way to solve the seepage problem. However, from a financial point of view, this solution would be very costly because the installation process is very expensive and requires special techniques and care. The need to remove all the riprap and provide a smooth layer as well as supports will increase the total cost. Al-Hashmi (2010) presented a cost estimate for the two remedial options.

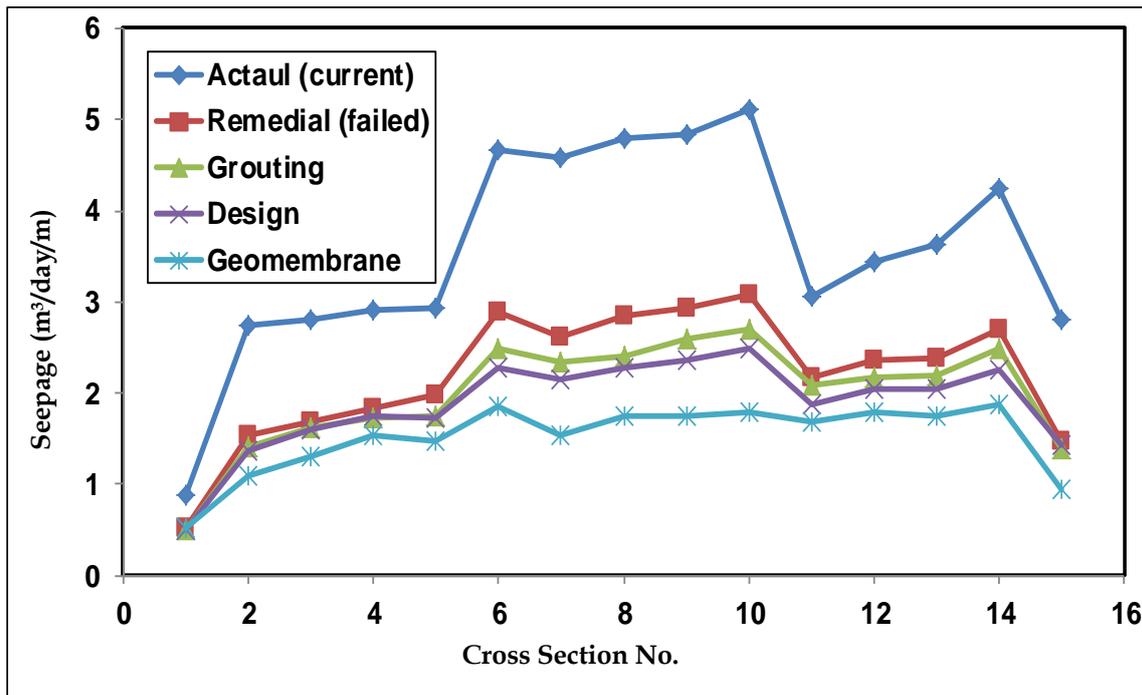
Figure 13. Seepage quantities profile of all cases.
