Scissoring of a Cobalt Alloy Aneurysm Clip causing Slippage during Cerebral Aneurysm Surgery

Case report and review of literature

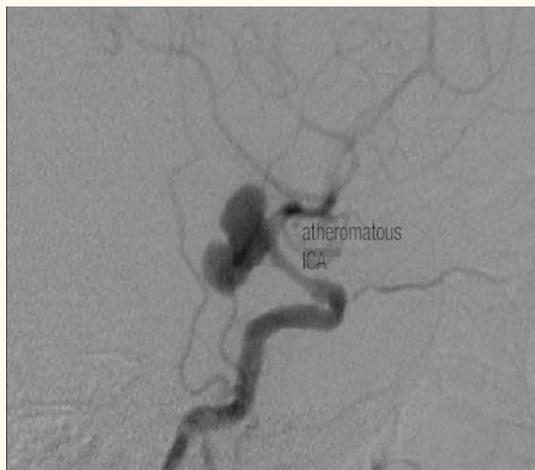
A 53-year-old hypertensive male presented with a good grade sub-arachnoid haemorrhage (SAH) of 3 days' duration. A computed tomography (CT) scan of the brain showed a Fischer grade 4 SAH with ventriculomegaly. A digital subtraction angiogram (DSA) showed a 1.47 cm trilobed internal carotid artery (ICA) aneurysm of the communicating segment with a 2.7 mm wide neck. There was irregular narrowing of the ICA, suggestive of atherosclerosis [Figure1].

Figure 1: Preoperative angiogram showing internal carotid artery (ICA) aneurysm.

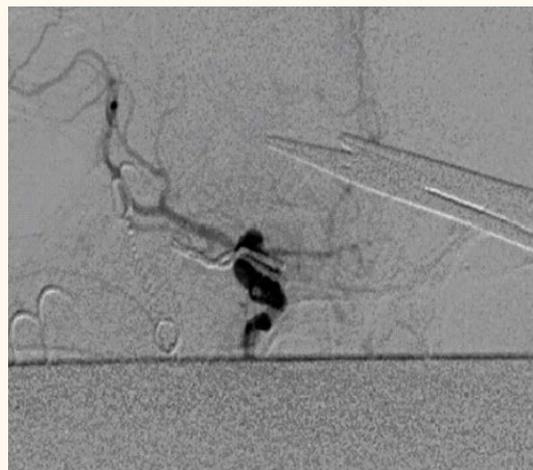
Figure 2: Intraoperative angiogram showing scissoring of clip and filling of aneurysm.

An intraoperative angiogram was then performed. The initial fluoroscopy images showed scissoring of the blades and the angiogram showed refilling of the aneurysm [Figure 2]. On returning back to the operative field, it was found that the aneurysm had refilled with blood, which was

alone. However, if the atheroma is non-uniformly distributed around the neck, one of the clip blades may gradually slide over a rigid part of the plaque, resulting in their scissoring over a short period of time after the clip placement, as occurred in this patient.

The third—and probably most important factor—is procedure-related. A good neck exposure freeing all adhesions, decreasing intra-luminal pressure, and choosing the right clip and final placement, all contribute to clip stability.¹⁴ Torsional forces created while re-adjusting a clip in a large atheromatous neck can also result in scissoring, especially if the plaque is hard and eccentric, thereby preventing proper apposition of the blades. Temporary clip occlusion of the ICA and aspiration of the aneurysm provide the best conditions for a satisfactory clipping in such circumstances; however, these were not considered due to the presence of gross atheromatous changes in the parent vessel as seen in the angiogram as well as during surgery. Parallel clipping was initially performed to avoid kinking of the ICA. An additional clip, parallel and distal to the first after collapsing the sac, might have prevented the slipping. In the end, a simpler clipping solution with a standard clip in a perpendicular direction was found to be effective.

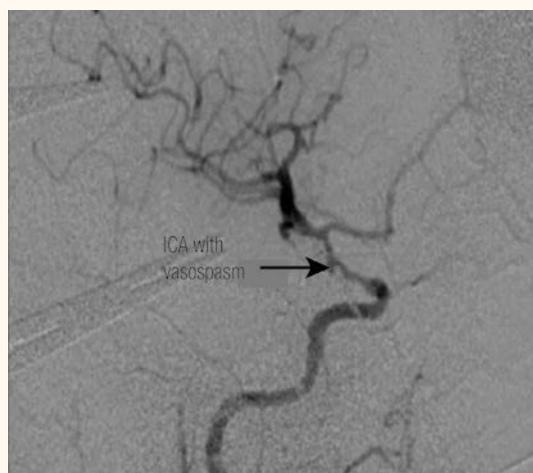
Temporary clipping was not considered due to the extensive atheromatous changes in the ICA. Instead the clip was gently de-rotated and removed. There was considerable distortion of the aneurysm neck, ICA, and MCA during this manoeuvre. Clipping was then achieved after a more complete dissection around the aneurysm neck, with a perpendicularly placed 9 mm curved cobalt alloy Yasargil aneurysm clip. The check angiogram was found to be satisfactory [Figure 4].

Figure 4: Final intraoperative angiogram showing complete clipping and vasospasm
