Performance of Cement-Based Patch Repair Materials in Plain and Reinforced Concrete Members

Abstract: Structural elements such as beams, slabs, and columns may require strengthening or repair during their service life. Different repair materials (RMs) are available and it is usually difficult to choose the best ones, especially when considering the cost of such materials. This paper presents the results of an experimental investigation of patch RMs on plain concrete prisms as well as on reinforced concrete beams. Three cement-based RMs available in the market with different mechanical properties and an ordinary Portland cement (OPC) mix produced in the lab were used in the study. Damage was induced in prisms/beams and then repaired using different materials. The experimental work included assessment of the flexural strength of damaged/repared plain concrete prisms; slant shear (bond) strength between the concrete and the RM; axial strength of damaged/repared plain concrete prisms and bond of the repair materials in damaged/repared reinforced concrete beams loaded to failure. The test results showed that all RMs performed well in restoring the strength of damaged plain concrete. Co

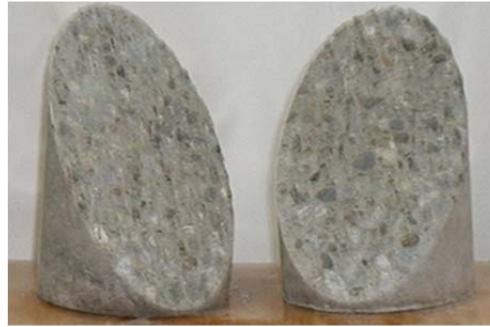
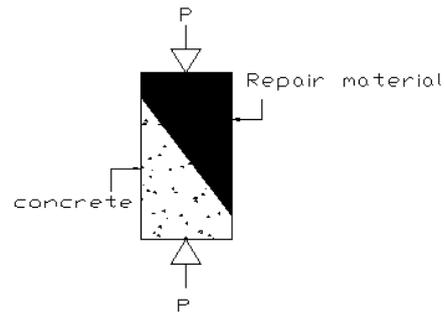
Figure 1. Slant Shear Test: (a) Concrete cylinder after cutting, and (b) Combined cylinder of repair material and concrete substrate.

The bond strength test (slant shear test) was done according to ASTM standard C882 using 75 x 150 mm concrete cylinders. Each cylinder was cut as specified in the standard at 30° by a concrete cutting machine after curing for 28 days (Fig. 1a). After cutting these cylinders, each piece was replaced in a cylindrical mold to cast the RM above it. Three specimens were used for each RM. Figure 1b shows the combined specimen after casting the RM.

The specimens were loaded axially in compression, which caused failure along the line where the two layers are jointed (Fig. 1). Bond strength was calculated by dividing the failure load by the interface area (ellipse area). The average bond strength (using three specimens) in N/mm^2 were 3.81, 4.97, 5.78, and 4.05 for RM1, RM2, RM3, and OPC, respectively. As can be observed, the maximum bond strength was $5.78 N/mm^2$ for RM3, whereas the minimum bond strength value was $3.81 N/mm^2$ for RM1. There was not much difference between RM1 ($3.81 N/mm^2$) and the control RM OPC ($4.05 N/mm^2$). The mode of failure was almost the same for RM1, RM2, and RM3, and failure occurred at the interface surface between the two materials (Fig. 5(a)). Failure of the OPC specimen was due to crushing failure (Fig. 5(b)).

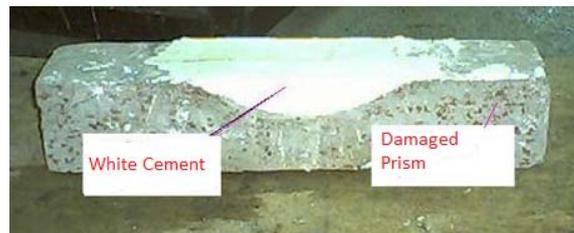
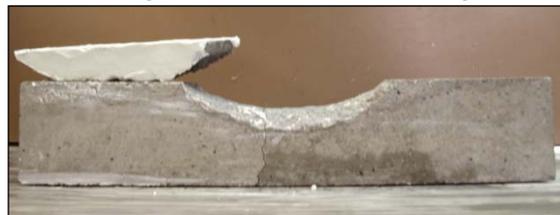
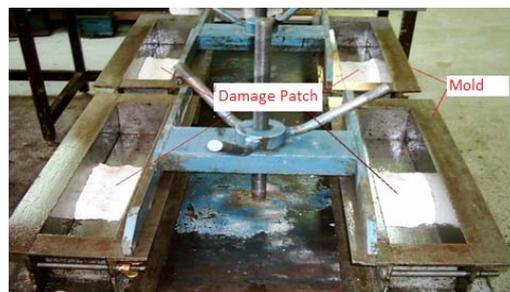
a) Casting of white cement in damaged area.

b) Removing the white cement patch.

c) Placing the white cement patch in the prism molds before casting.

Figure 2. Preparation of damage mold to induce uniform damage in prisms.

create a damaged section measuring 200 mm in length with a maximum depth of 25 mm within the middle third of the prism (Fig. 2). To accomplish this specific type of damage, a concrete prism was damaged by chipping the concrete with 200 mm width and a maximum depth of 25 mm. To simulate the actual damage in concrete, the damage made by chipping the concrete was not uniform. After chipping, the damaged area was patched with white cement mortar. Once the white cement patch had set, it was removed from the concrete with all of the rough surfaces imprinted on the surface of the patch. The patch was then placed in the prism mold before casting (Fig. 2(c)). After casting, this patch was removed from the prism, creating the required damage. The same procedure was repeated with the other specimens. In this way, the damage in all specimens was uniform in order to make a fair comparison between all RMs.

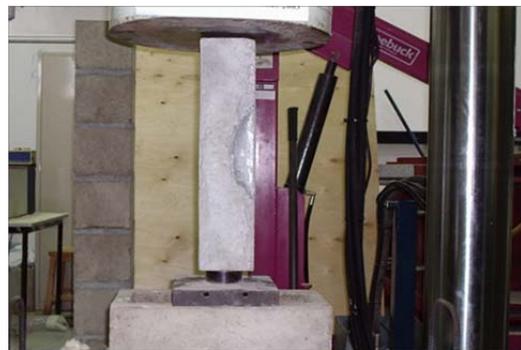
Figure 3. Test setup of plain concrete prisms under axial compression.

In addition to flexural strength, a compressive strength test was done on the plain concrete prisms. Six prisms were tested for each RM: two undamaged, two damaged, and two damaged/repaired prisms. The failure load was recorded for each prism, and the compressive strength was calculated. Figure 3 shows the test setup of plain concrete prisms under axial compression.

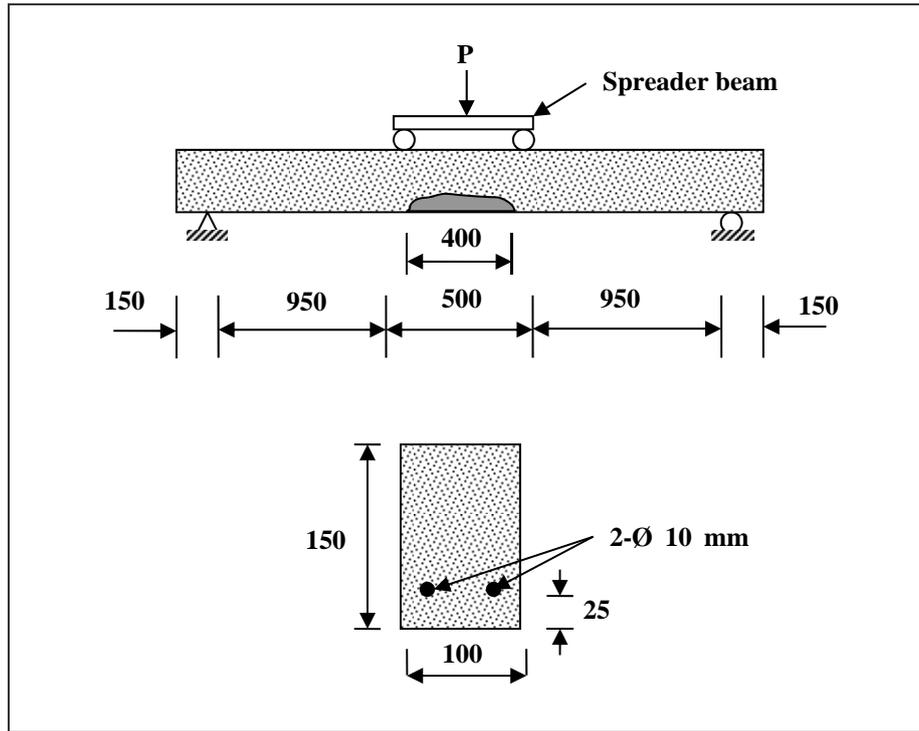
Figure 4. Test setup of reinforced concrete beams.

The reinforced concrete beams were simply supported and subjected to four-point bending (Fig. 4). The beams were supported over 2,400 mm. Linear variable differential transducers (LVDTs) were used to measure deflection at the mid-span of the beam. All beams were loaded at a rate of 0.06 kN/s until the failure load was reached.

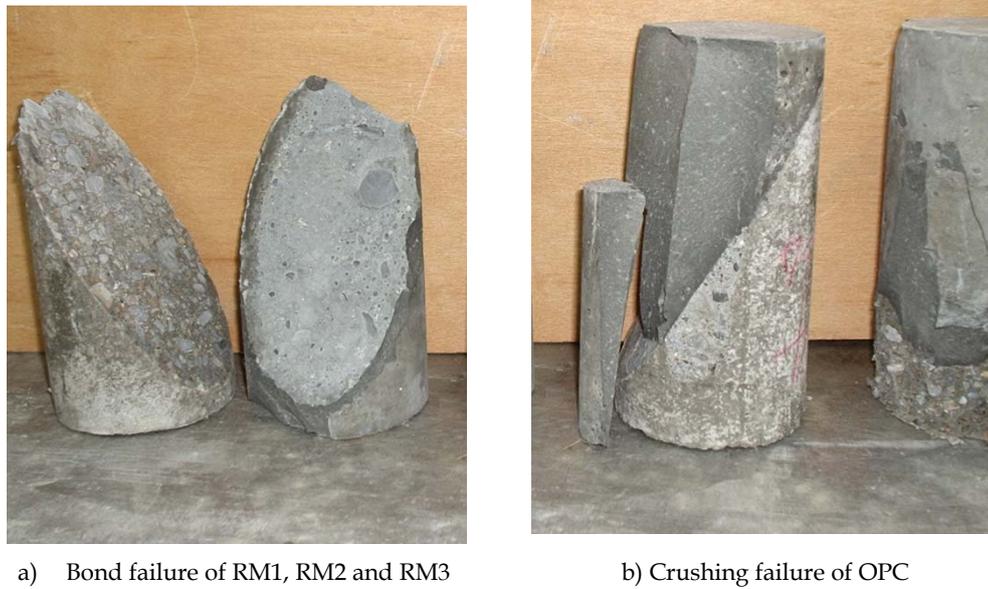
Figure 5. Modes of failure of the specimens observed during Slant Shear Bond test.

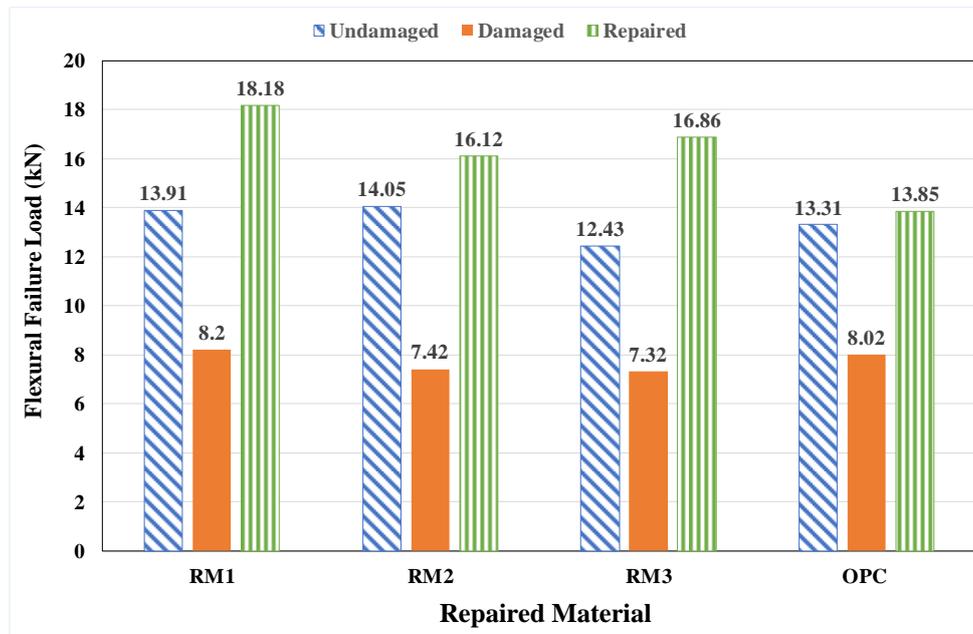
Figure 6. Flexural strength of prisms.

A summary of the results of the flexural strength of the undamaged, damaged, damaged/repared prisms is shown in Fig. 6. Here the failure load which caused the prism to

break was reported instead of the flexural stress or modulus of rupture, since the latter might be misleading in the case of damaged prisms where the cross-sectional area was reduced as a result of the damage. It can be seen that the damage caused large reduction in the flexural strength by 45% of the undamaged prism. However, all repaired prisms failed at a higher load than that of the undamaged prisms. An increase in the failure load of 30%, 14%, 36%, and 5% were observed in prism repaired using RM1, RM2, RM3, and OPC, respectively. This clearly shows that the RMs are very effective

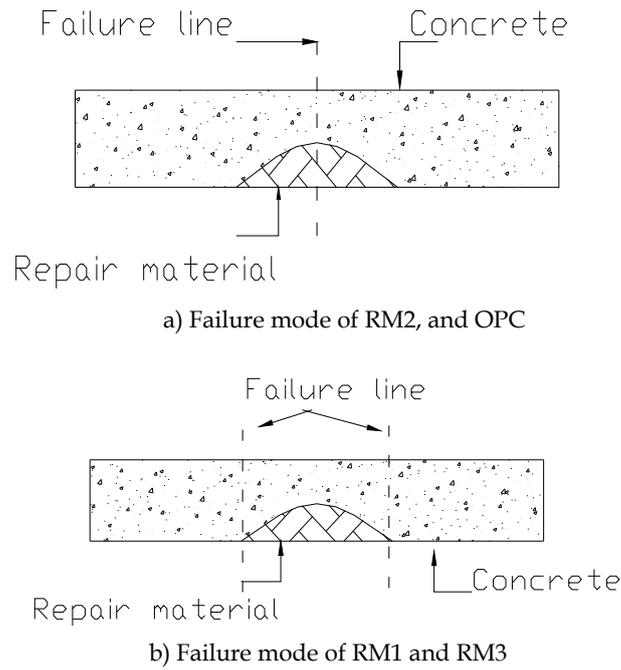
Figure 7. Schematic of failure modes in damaged/repared prisms.

when loaded under tension. In all prisms, no debonding failure was observed. The location of the cracks and the failure lines of the prisms are shown in Fig. 7. RM1 and RM3 were so strong that the concrete cracked just at the end of the patch where the substrate concrete was weaker in tension than the RM (Fig. 8).

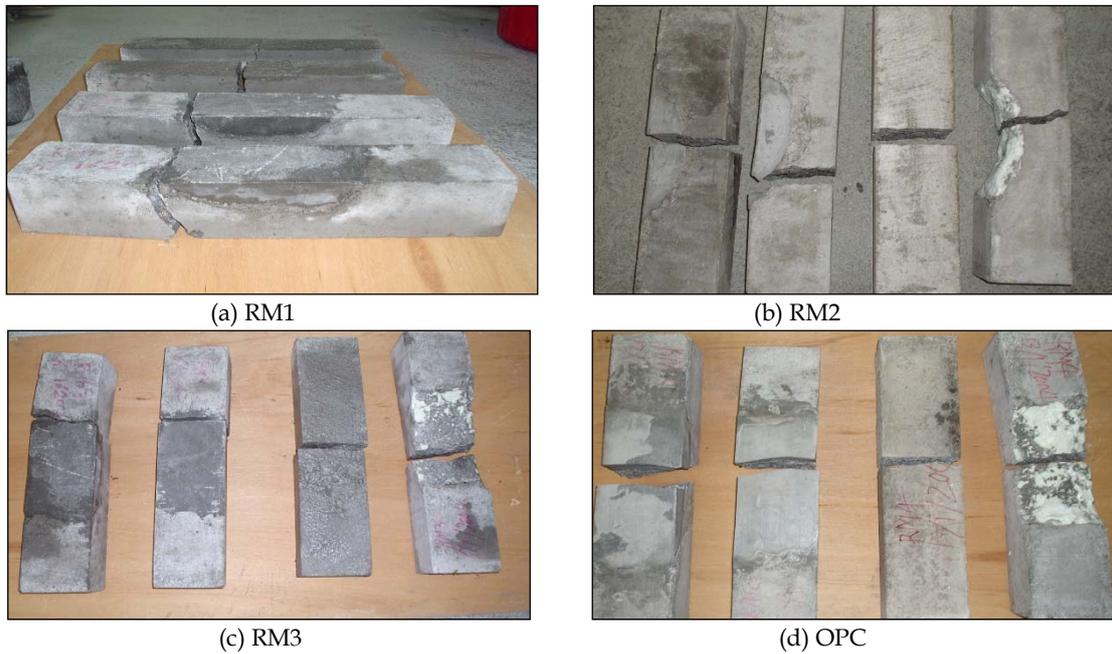
Figure 8. Modes of failure observed during flexural test of prisms for all repaired materials.

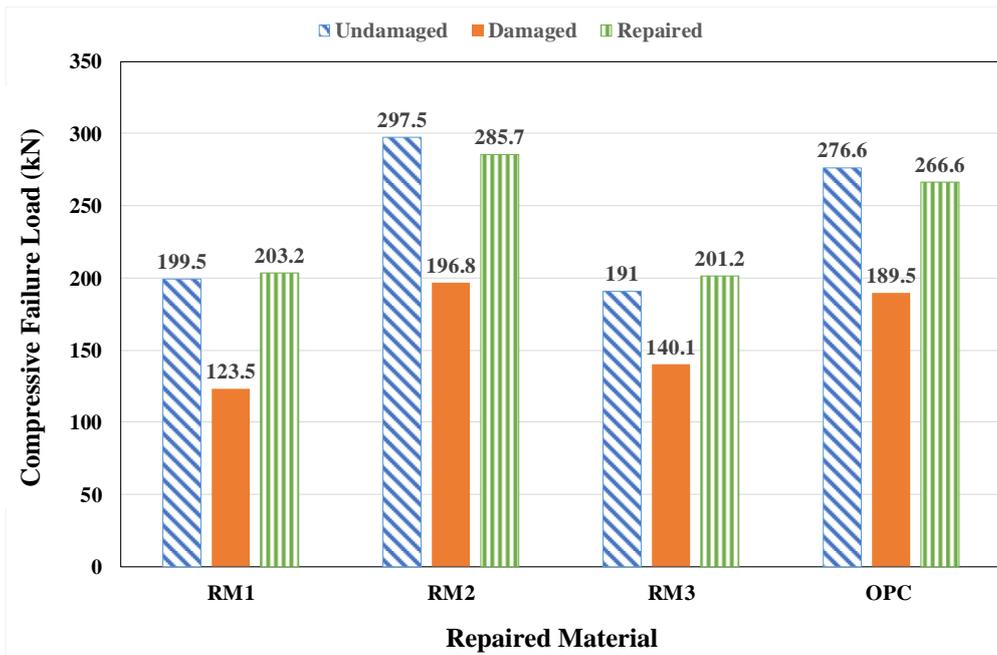
Figure 9. Compressive strength of prisms.

repaired similarly; however, they were tested under axial compression. A summary of the results of the compressive strength of the undamaged, damaged, damaged/repared prisms is shown in Fig. 9. As expected, all damaged prisms failed at a lower load than the undamaged and repaired prisms due to the

reduced cross-sectional area caused by the damage. However, all damaged/repared prisms showed equal or higher failure loads compared to the undamaged prisms, indicating that the RM contributed to the axial load carrying capacity of the damaged/repared prisms.

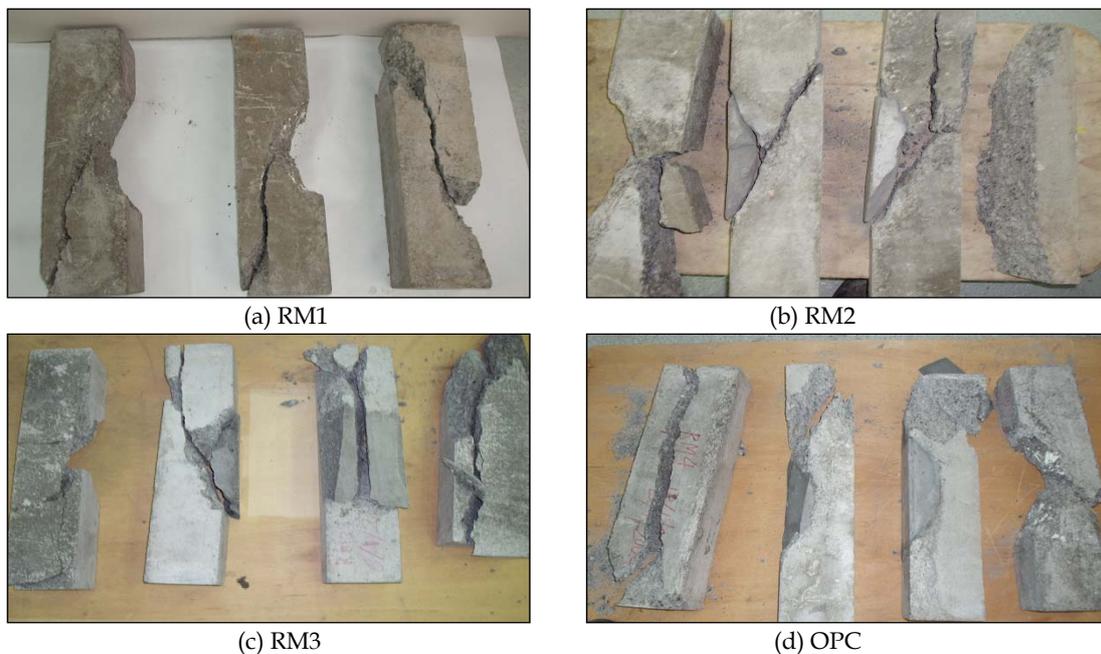
Figure 10. Modes of failure observed during compressive test for all repaired materials.

In the compressive strength test, the specimens repaired with OPC failed due to compression without detachment of the repair material from their locations, while, the other specimens repaired with RM1, RM2 and RM3 failed due to shear because the RMs detached from their locations as indicated by the inclined failure line in Fig. 10. The OPC RM showed better bond behavior under compression which was also observed in the slant bond test discussed in Section 5.1.

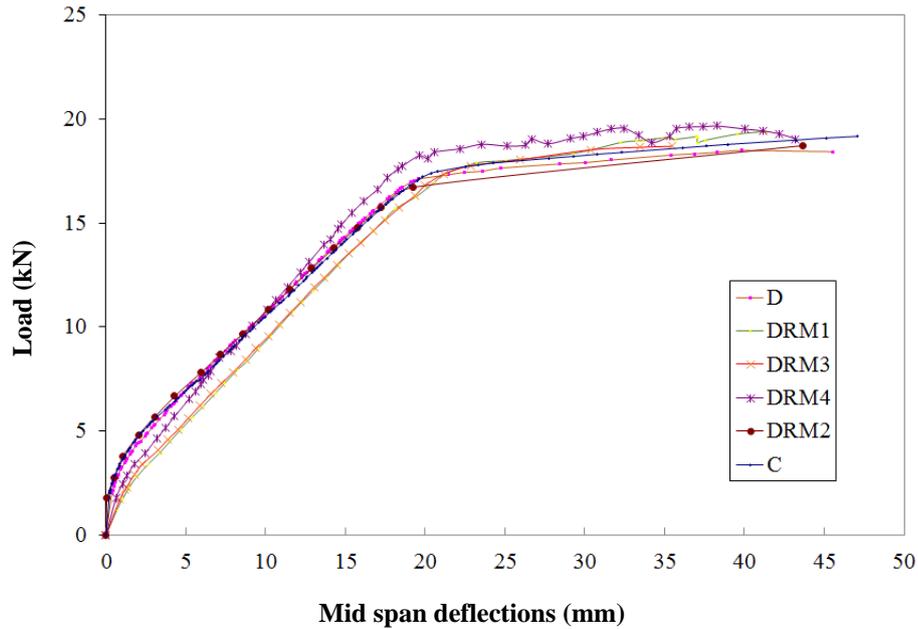
Figure 11. Load vs. mid span deflection of undamaged, damaged, and damaged/repaired beams.

Unlike plain concrete, which is very brittle, reinforced concrete behaves in a ductile manner. Therefore, it was possible to observe the behavior of the combination of repair + concrete in all loading stages as encountered in the field. Load versus mid-span deflections are compared in Fig. 11, showing the undamaged, damaged, and damaged/repaired beams. From Fig. 11, it can be observed that all of the repaired beams resisted an ultimate load slightly higher than the undamaged beam. All beams failed in a

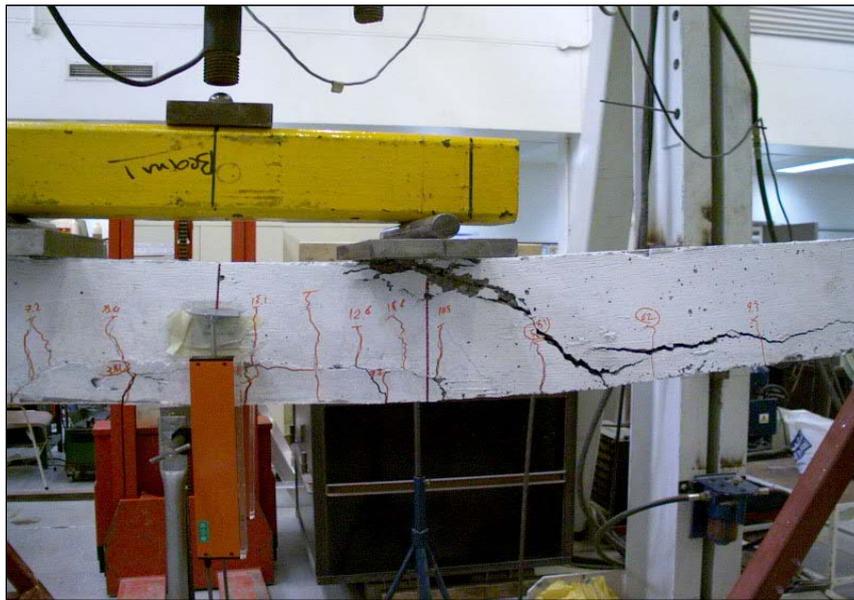
Figure 12. Repaired beam after failure.

DRM1, the cracks first appeared in concrete at 3.3 kN whereas in the RM the cracks appeared at 5.6 kN; the other repaired beams also followed the same pattern (Table 4). The variations in crack appearance can be attributed to the difference in the tensile strength as the RMs have higher tensile strength than the concrete substrate. In all beams, the RMs remained attached to the concrete until the beam failed (Figs. 12 and 13), and no major difference was observed among the repairs made with different materials.

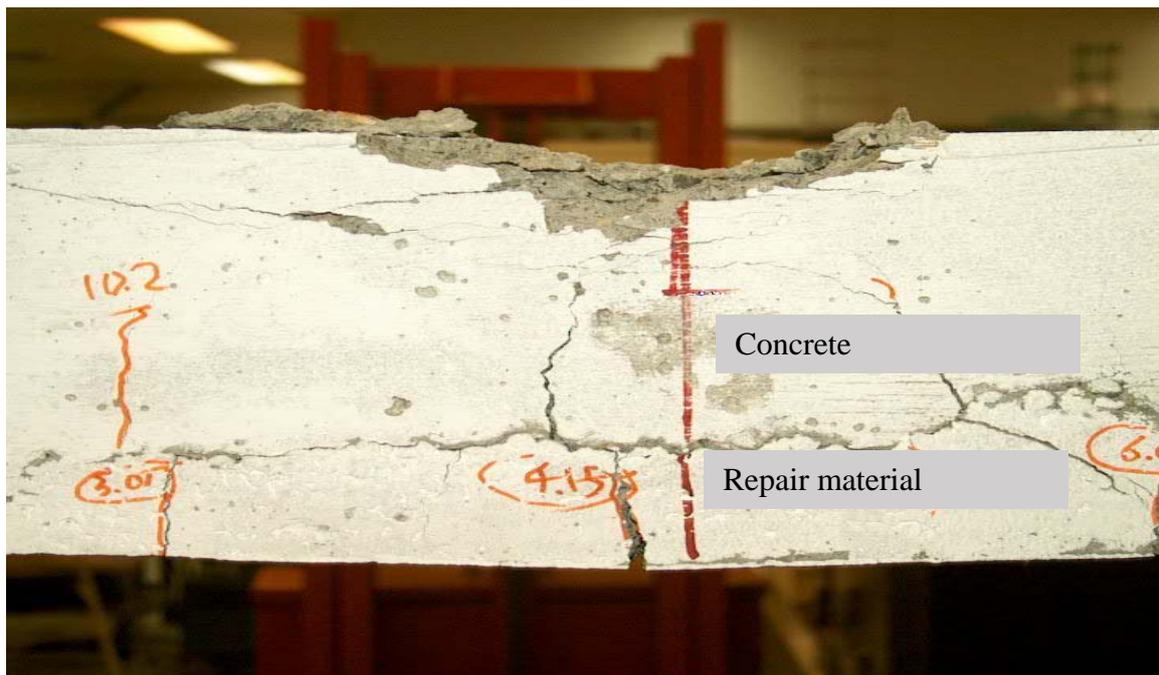
Figure 13. Close up view of the repair material (RM2) at failure.
