DETERMINATION OF ROCK SLOPE STABILITY USING STEREOGRAPHIC PROJECTION BETWEEN SULAV AND AMADIYAH RESORTS – A STUDY FROM NORTHERN IRAQ

ABSTRACT: Geological discontinuities play a significant role in the assessment of rock slope stability. Rock slope stability has been studied on the main road between Sulav and Amadiyah resorts in Duhok governorate on the southern limb of Mateen anticline, to determine the expected rockslides on this road. Five stations were chosen to study these rockslides that may occur on these steep slopes. All these stations were within the Pila Spi Formation that consists of hard dolomitic limestone and covering the areas from Sulav resort towards Amadiyah district with a length of up to 2.5 km. The stereographic analysis was used to study and classify the stability of these slopes. The analysis showed in all stations the possibility of plane sliding to happen on the bedding plane, and the wedge sliding between the bedding plane and planes of all joint sets, as well as the occurrence of rockfall on some stations.

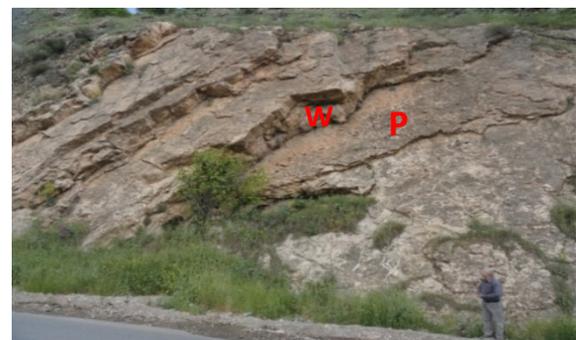
Figure 5. Showing the plane sliding (P), and the wedge sliding (W) at station 1.

The slopes of the dolomitic limestone of Pila Spi Formation were exposed on the left side of the main road overlooking the entrance of Sulav resort. This station is characterized by the possibility of the plane sliding on the bedding planes, which also represents the slope face, and the wedge sliding between the bedding planes and the discontinuities represented by the joint sets (S1, S2, S3, and S4) because the friction angle of the sliding surfaces is less than their dip angle (Fig. 4 and Table 1). Such joints also act as lateral release surfaces for sliding (Fig. 5).

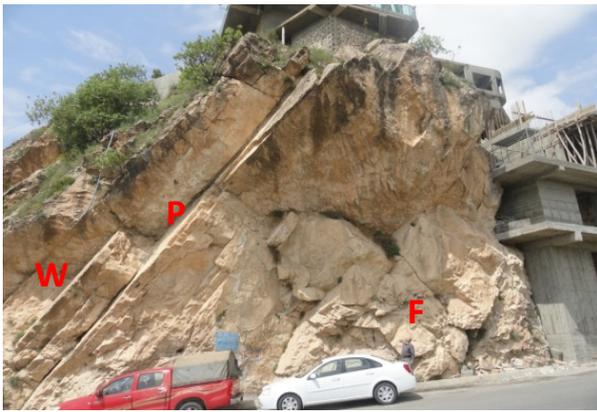
Figure 8. Showing the rockfall (F), and the plane sliding (P), and the wedge sliding (W) at station 2b.

The first part of this station is the extension of the first station. The landslides are of two types: the plane sliding on the bedding plane, and the wedge sliding between the bedding plane and the same joint sets referred to in station 1, (Figs., 6(a), and 7). Whereas rockfall, plane, and wedge sliding occur in the second part of the station, because of changes in the direction of the main road and its intersection with the bedding strike (Figs., 6(b), and (8)). The presence of the joints helps to cause rockfall in this part of the station. Rockfall occurs on steep slopes; therefore the unstable rocks are difficult to stay in their position due to the effect of the joints so that they fall to the bottom of the slope. Some of the rockfalls are gathered in very narrow longitudinal ditches that have been prepared for this purpose. It is noted that most of these blocks settle down on the main road due to the narrow area of the shoulder of the road. Such blocks are nearly a few meters away from the buildings in Sulav resort, which threatens to destroy them and cause endanger to their inhabitants, as well as to cause significant environmental hazards (Fig. 8).
