An Investigation of Excessive Seepage from the Al-Fulaij Recharge Dam, Oman

Abstract: The Al-Fulaij recharge dam is located on the Al Batinah coast in Oman and was constructed in 1992. The dam is about 3.3 km long and 7.7 m high with a storage capacity of 3.7 million cubic meters of water. It is an earthfill dam with silty, sandy gravel fill in the embankment. Excessive seepage of between 5,000–12,500 m³/day was observed during floods in 1993, and several sinkholes were noticed close to the upstream toe. Remedial work consisting of an upstream blanket and a cut-off trench wall was performed in 2000. However, these remedial measures failed and almost the same seepage was noticed again during the impoundment. This paper investigates possible causes of the seepage using a finite element model. The input data for the model were collected from site investigations and field records during the construction and monitoring of the dam. The study reveals that the most probable cause of the excessive seepage is the presence of a permeable soil layer underneath the dam due to the dissolution of the gypsum material.

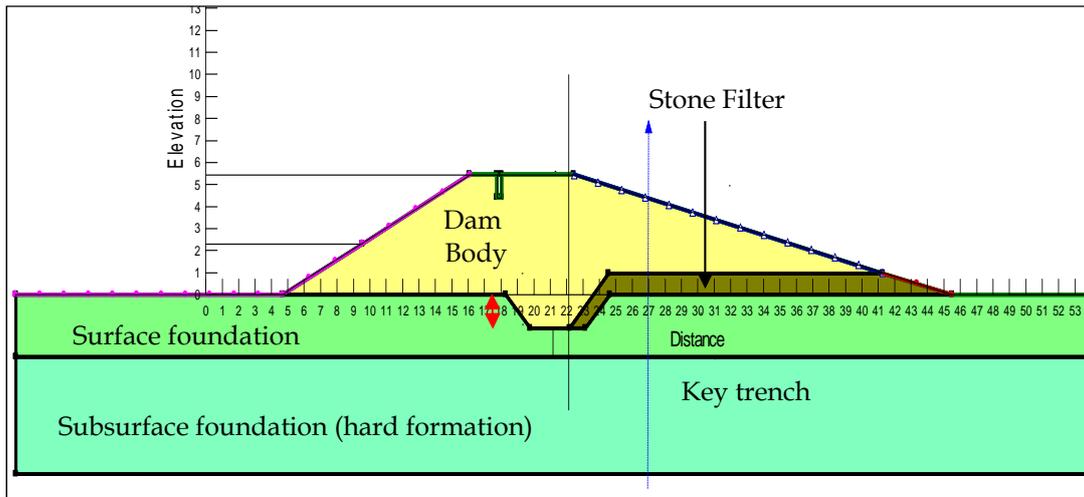
Figure 7. Design case of the dam as modeled in the program (SEEP/W 2007).

To show the effect of the presence of the permeable layer underneath the dam on the seepage quantity, the problem was modeled according to the design case and the actual case. The design case represents the dam without the causes of the seepage problem. This means that the presence of the gypsum material at the site was not considered since it was not evaluated properly during the design stage; hence, the values of the hydraulic conductivity (k) of the different material are as shown in Table 5, and the case is shown schematically in Fig. 7.
